Service Bulletin

Affected product: LulzBot Single Extruder Tool Head v2

Effective date: June 3, 2015

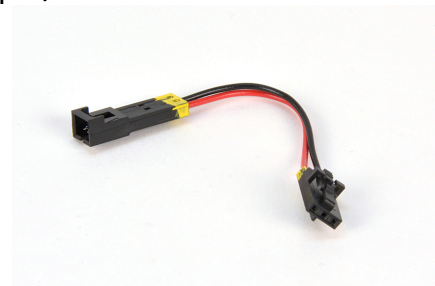
Correct jumper (Input to Output):

Service issue: Some LulzBot Single Extruder Tool Head v2 may have an incorrect jumper wire included. The incorrect jumper contains: three pin output to three pin output. The correct jumper contains: two pin input to three pin output.

Incorrect jumper (Output to Output):

Contact the Support Team by sending an email to Support@LulzBot.com with the following information:

- Shipping and Contact information
- Order number for LulzBot Single Extruder Tool Head v2 purchase

A replacement jumper will be sent at no cost to you. We apologize for any inconvenience this may have caused and appreciate your business.
